Study into the Correlation Between Levels of the River Wharfe Recorded at Ilkley and the Safe Availability of Passage Across The Stepping Stones at Burley in Wharfedale

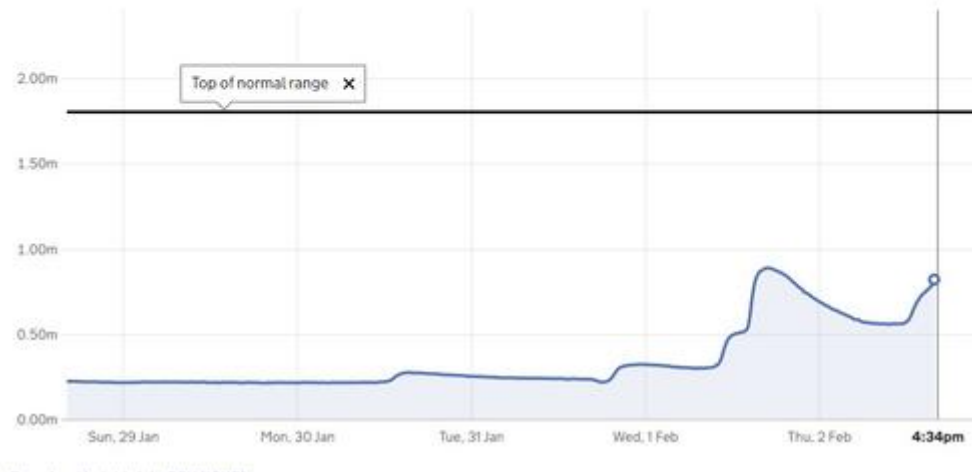
Height over the last 5 days

State
Normal
0.09m to 1.80m

Height
0.81m
at 4:00pm today

Height data for the Wharfe, from the Government check-for-flooding service at <https://check-for-flooding.service.gov.uk/station/8106> is available, year by year on a daily basis at low, average and high levels. Given that this river can rise very quickly (see diagram on page 3), it is considered that only the higher of the daily figures should be used, in the interests of safety.

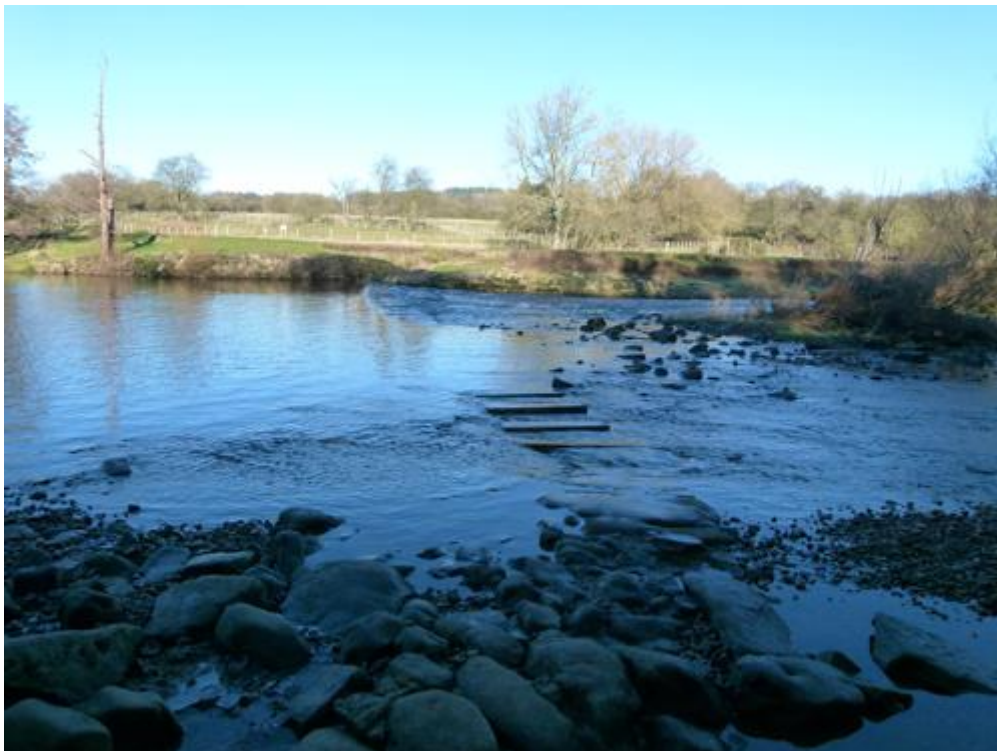
Photo taken 19 January 2023. Recorded river level 0.32m

It was not considered that the stepping stones were safely passable on 19 January 2023 at this level. The central stones were under several inches of water.

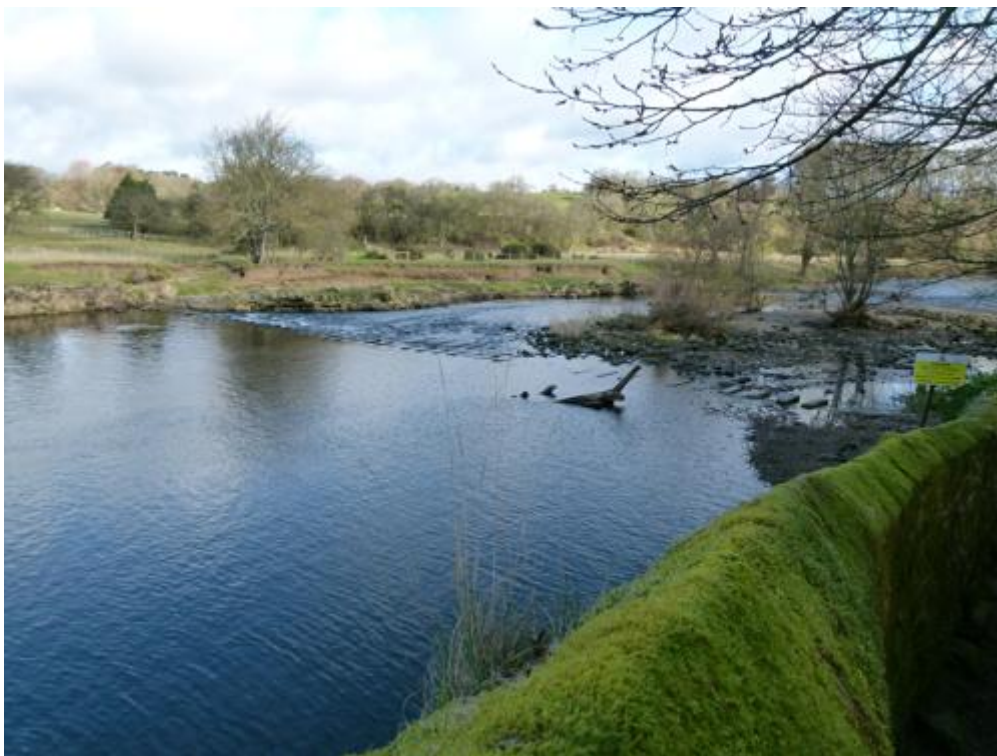
Photo taken 11 February 2023. Recorded river level 0.20m

The central stones are still covered.

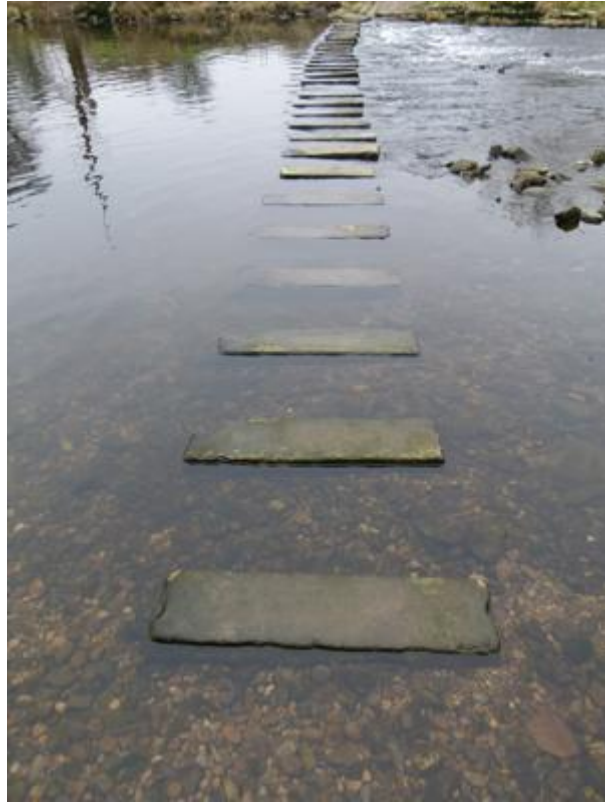
Close up of central stones 13 February 2023

Although the central stones are becoming visible, there is still a shallow covering which could lead to them being slippery.

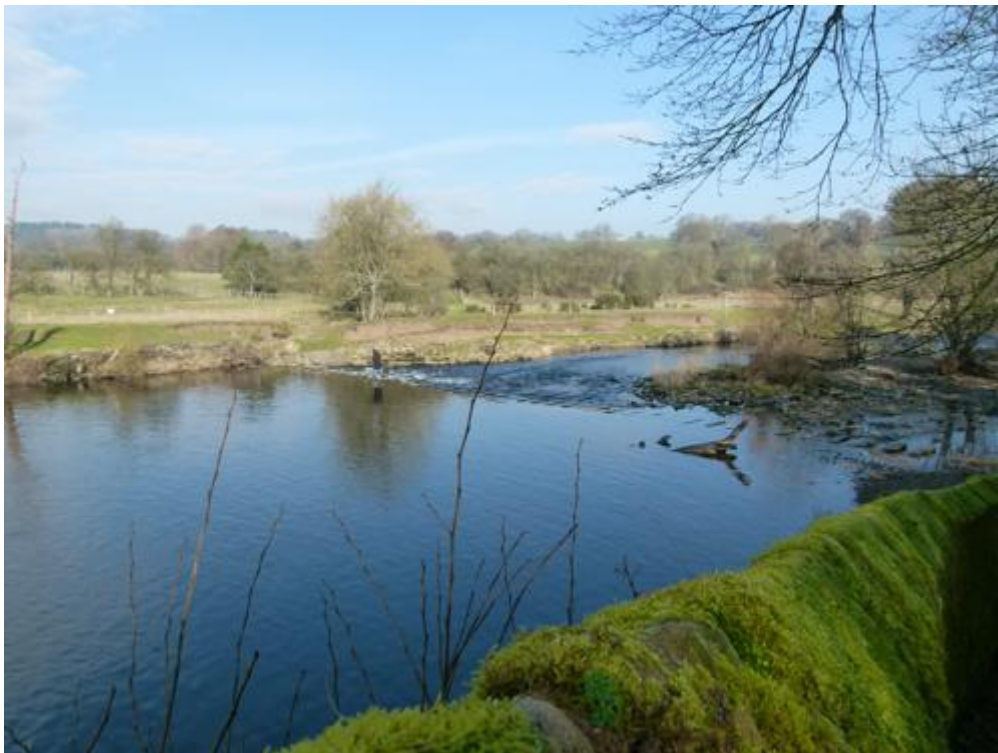
Photo taken 14 February 2023. Recorded river level 0.17m

The surface of the central stones is just above the water. In fact there is a person crossing the stones who also returned without difficulty.

It is considered that a safe level for crossing the stepping stones cannot occur until the river level at Ilkley is recorded at 0.17m or less. Even at this level, the surface of a couple of stones is level with the surface of the water. A breeze can blow water across the surface of the stones so great care needs to be taken to avoid slipping.
